Study of **Blackrock Beach** **County Louth**

AQUAFACT International Services Ltd

On behalf of Blackrock Tidy Towns

November 2009

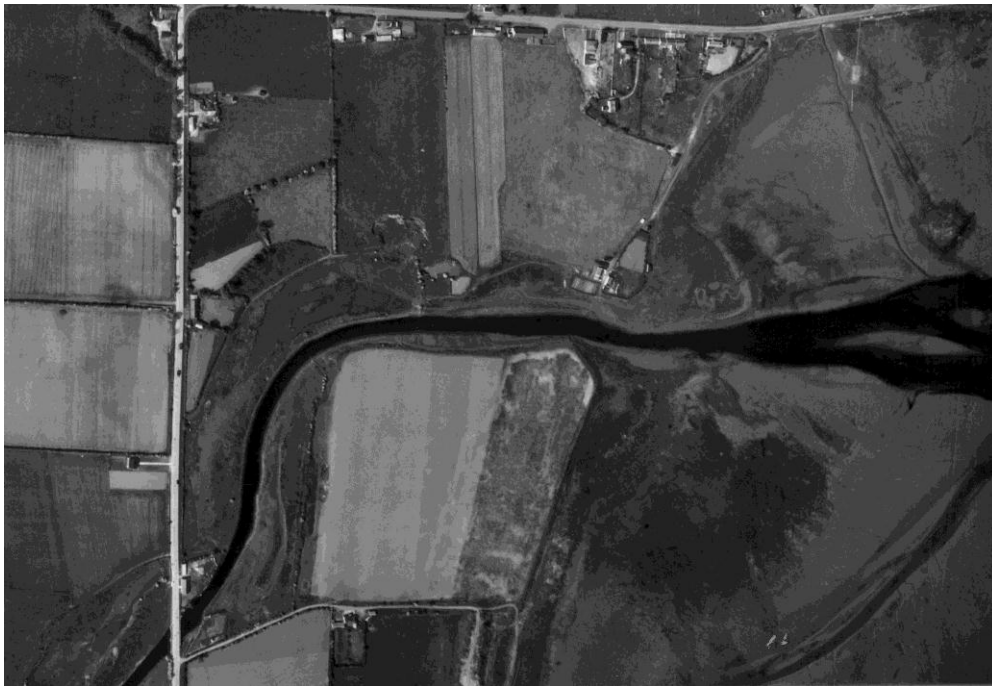
Figure 2-2: Aerial photography of area of interest (1954). (The eastward route of the river into Dundalk Bay is not shown in this image).

Looking at the navigation chart and aerial photographs attached (Figure 2-1 - British Admiralty chart – data collected in 1843; Figure 2-2 – aerial image of the Fane estuary taken in 1954 by the Irish Air Corps; Figure 2-3 – aerial image taken in 2004), it can be seen that the course of the river has not changed much over a time-scale of approximately 160 years. The overall morphology of the river bed east of the mouth looks much the same in the three images and the seaward section of the estuary as shown in Figures 2-1 and 2-3 are also quite similar even down to the detail of small drainage channels that run from the mud flats into the bed (Figure 2-2 does not extend as far to the east as does Figure 2-3). The width of the river bed in Dundalk Bay is narrower in the Admiralty Chart than in the 2004 aerial image. It is uncertain what effect this may have on sediment distribution/removal from the Blackrock beach site. The banks that are exposed at low water just east of the mouth of the river are somewhat similar over the 160-year time scale. One small feature that is present in the area of the sand banks on Figure 2-3 is not marked in Figure 2-1 – this is a small drainage channel that runs from the north to join the river channel. This may have been too small to have been surveyed by the Hydrographic Office in 1843.

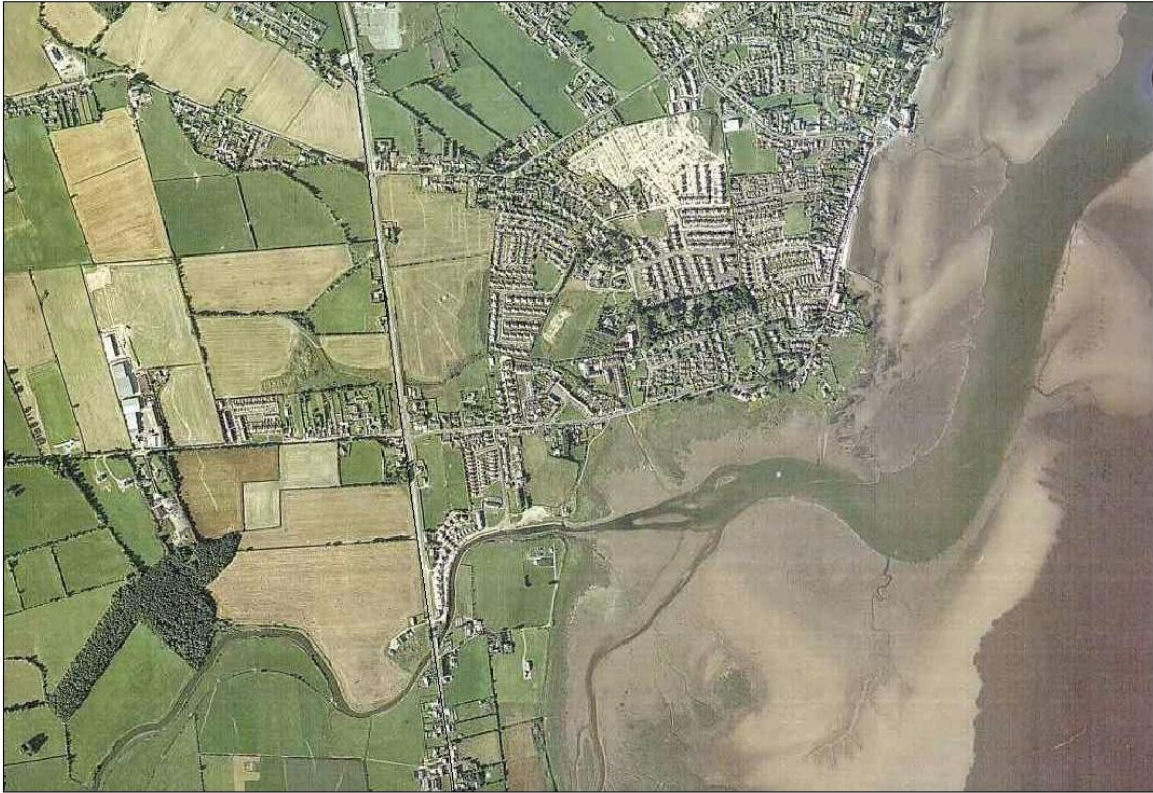
Figure 2-3: Aerial photography of area of interest (2004).

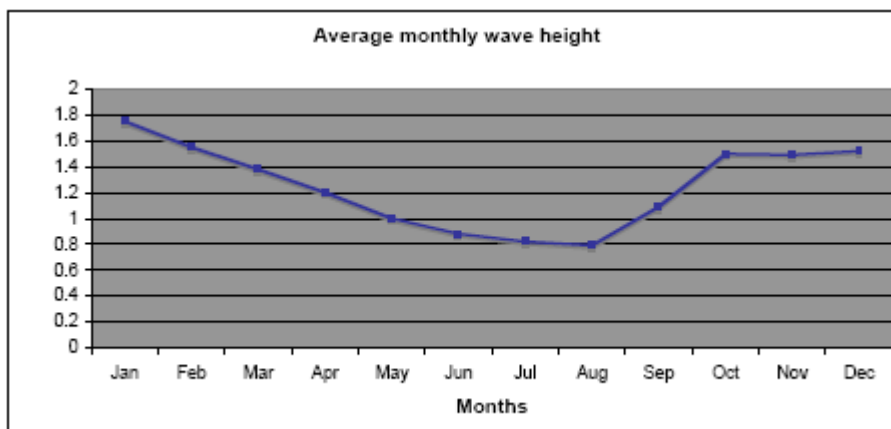
Figure 2-6: Average monthly wave height recorded at the M2 weather buoy, 2001 – 2006.

The average wave height for each month (Figure 2-6) shows that the highest average wave height is in January at 1.73m.

The average wave height drops consistently through the spring and early summer before levelling off at between 0.84 and 0.795m during June, July and August. Average wave height then climbs rapidly in September before levelling out at 1.5m for October, November and December.

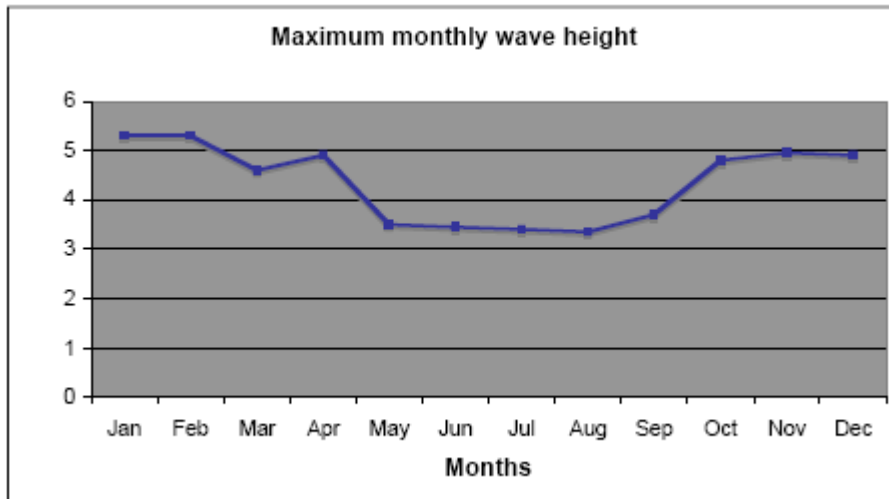
Figure 2-7: Maximum wave heights recorded at MS wave buoy in the Irish Sea.

The maximum monthly wave heights (Figure 2-7) were highest in January and February both with wave heights of 5.3m. The values dropped considerably during late spring and summer with values in the range of 3.2 to 3.5m recorded between May and August. Values increase again to between 4.8 and 4.9m in October, November and December.

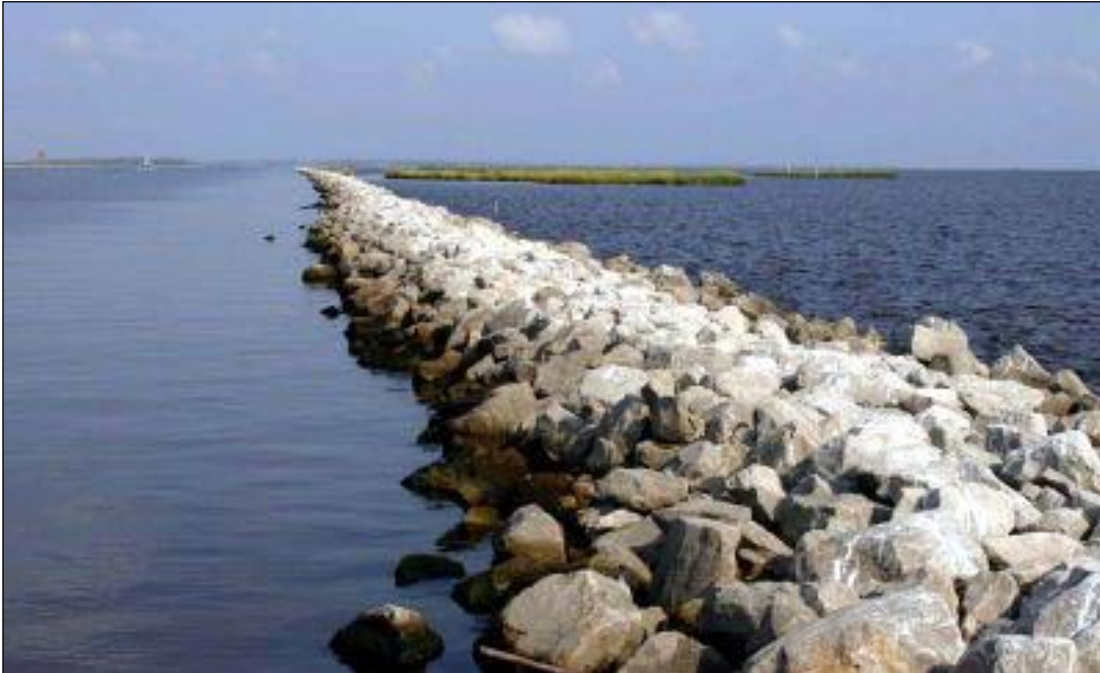
Figure 2-9: Example of a rock wave barrier

Wave barriers (see Figure 2-9) can be utilised to reduce the wave energy before it reaches a beach. In general, sand moves offshore during storm events and onshore during periods of low wave energy. The standard wave barrier is a Dutch fence made up of brushwood or sunken poles and arranged in the form of a box. The inner line protects the beach while the outer line acts as the main barrier to wave attack. While the primary purpose of this fence is to absorb wave energy to protect the sand at the base, it will also encourage sand build up. Although such structures will temporarily block onshore access of flotsam and jetsam (including floating weed), once the sea overlaps wave barriers, the floating material will then be brought on the beach with the rising tide.

Wave barriers are also constructed using large boulders (*circa* 3 tonne), placed at right

angles to the incoming waves. The irregular nature of this construction helps to diffuse the energy in the wave before deflecting it away from the shore.

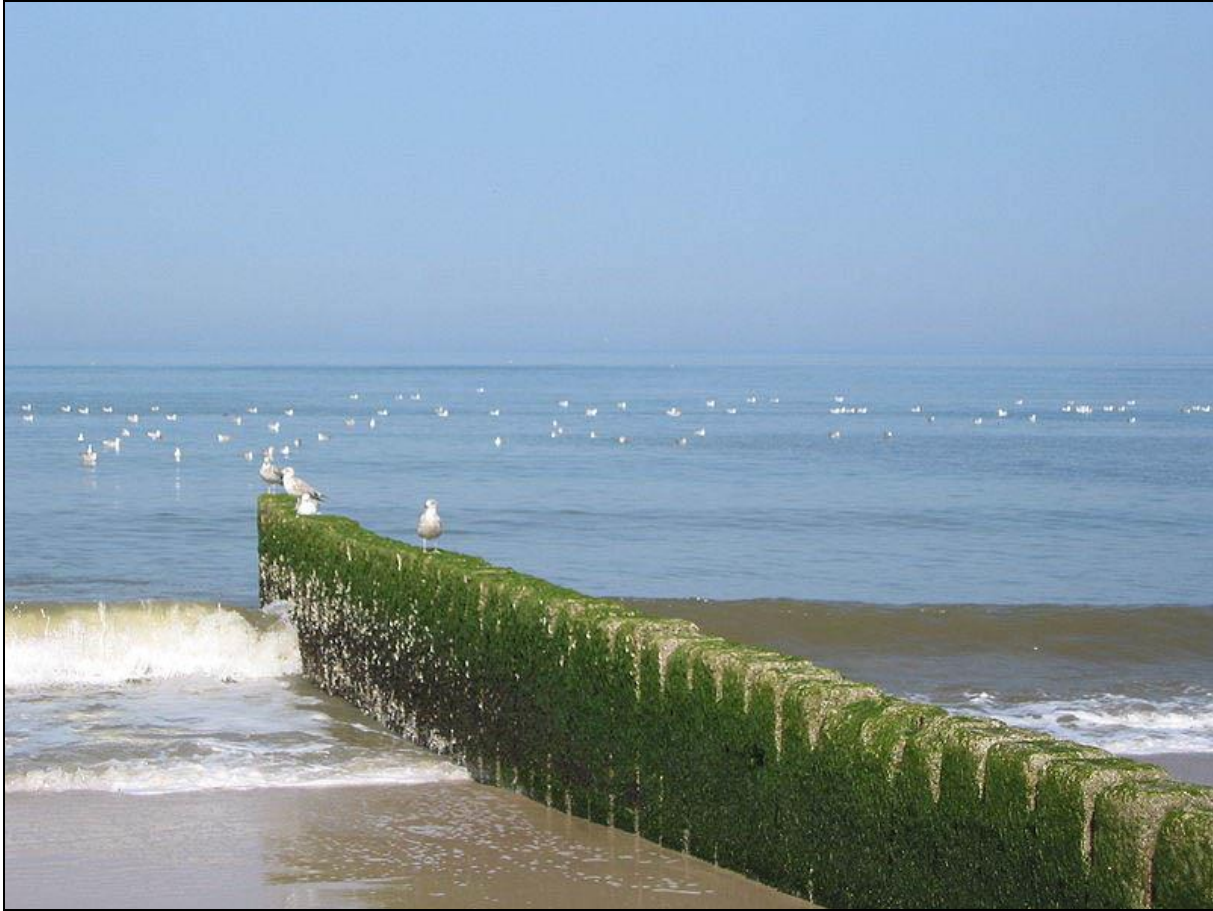
Figure 2-10: Example of a groyne

A groyne creates and maintains a wide area of beach or sediment on its updrift side, and reduces erosion on the other. It is a physical barrier that reduces sediment transport in the direction of longshore transport. Groynes do not add additional material to a beach but merely retain some of the existing sediment on the updrift side of the groynes. If a groyne is correctly designed, the amount of material it can hold is limited. However, if a groyne is too large it may trap too much sediment which can cause severe beach erosion on the down-drift side.

In relation to rock structures on the shoreline, the rock size, face slopes, crest elevation and crest width must be designed with care. Rock size is dependent on incident wave height, period and direction, structure slope, acceptance of risk, cross-sectional design and the availability/cost of armour rock from quarries. In general 1-3 tonne rocks are sufficient for the landward parts of the groynes, provided that they are placed as at least a double layer with a 1:1.5 to 1:2.5 face slope, and there is an acceptance of some risk of failure. Larger rocks, probably 3-6 tonne, may be needed for the more exposed body and seaward head of each

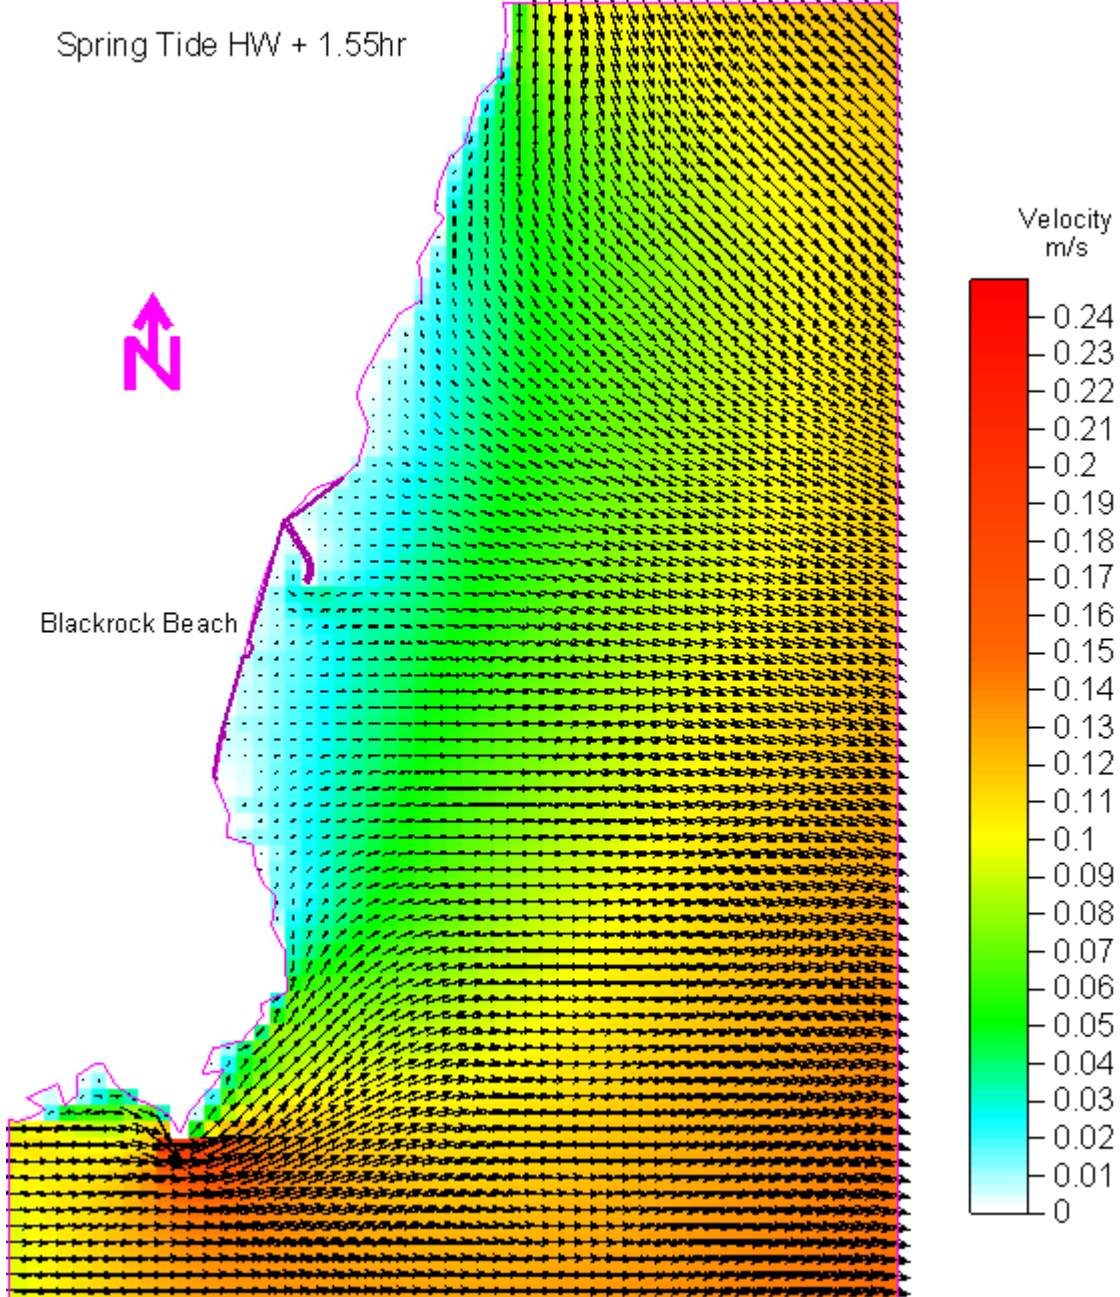
Figure 2-18. Currents at High Water +1.55 hour at Blackrock with wave barrier.

The recommended wave barrier as shown in Figure 2-11 was added to the model, and Figures 2-17 and 2-18 show the predicted velocities at Blackrock beach with the structure in place. Velocities decrease to 0 cm sec on both sides of the structure.

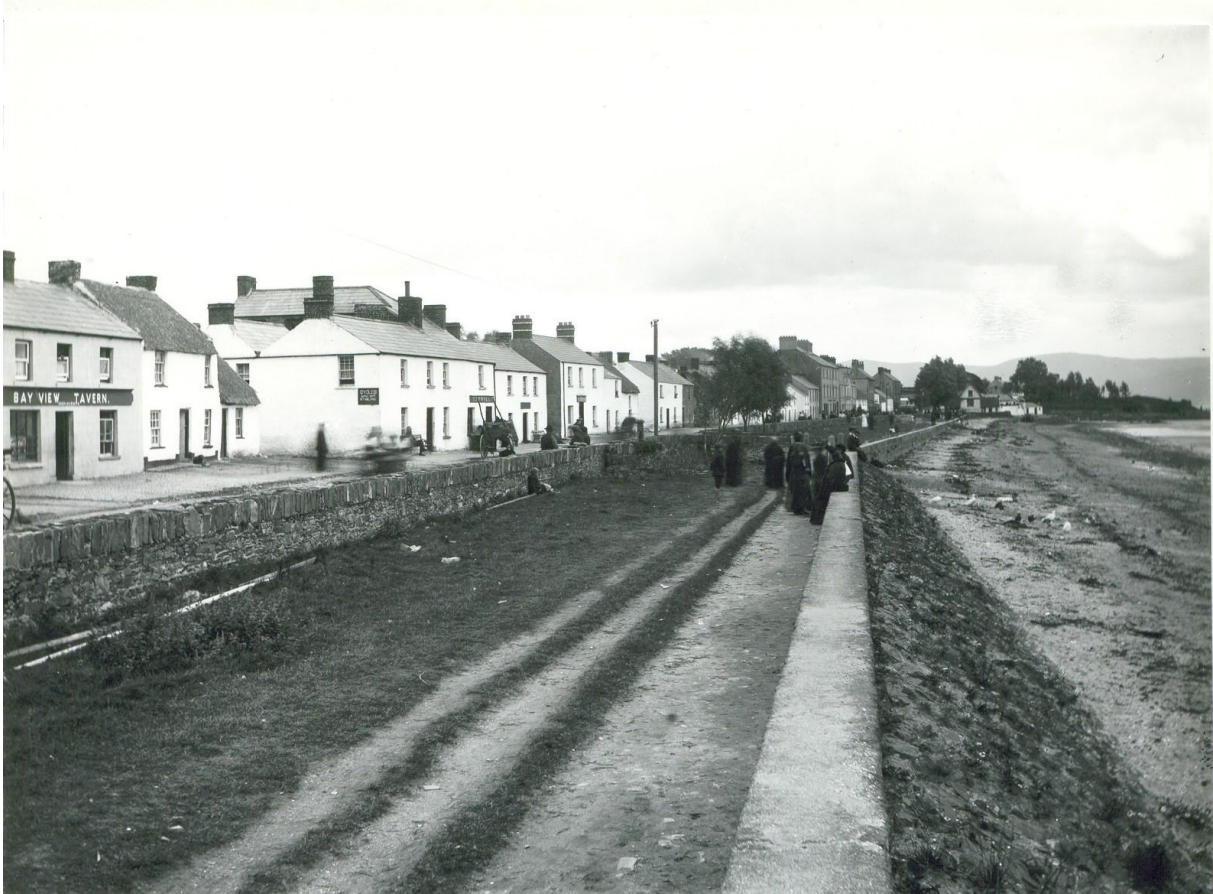
Photo 1: Beach and promenade *circa* 1890. Note band of dry sand below sea wall.

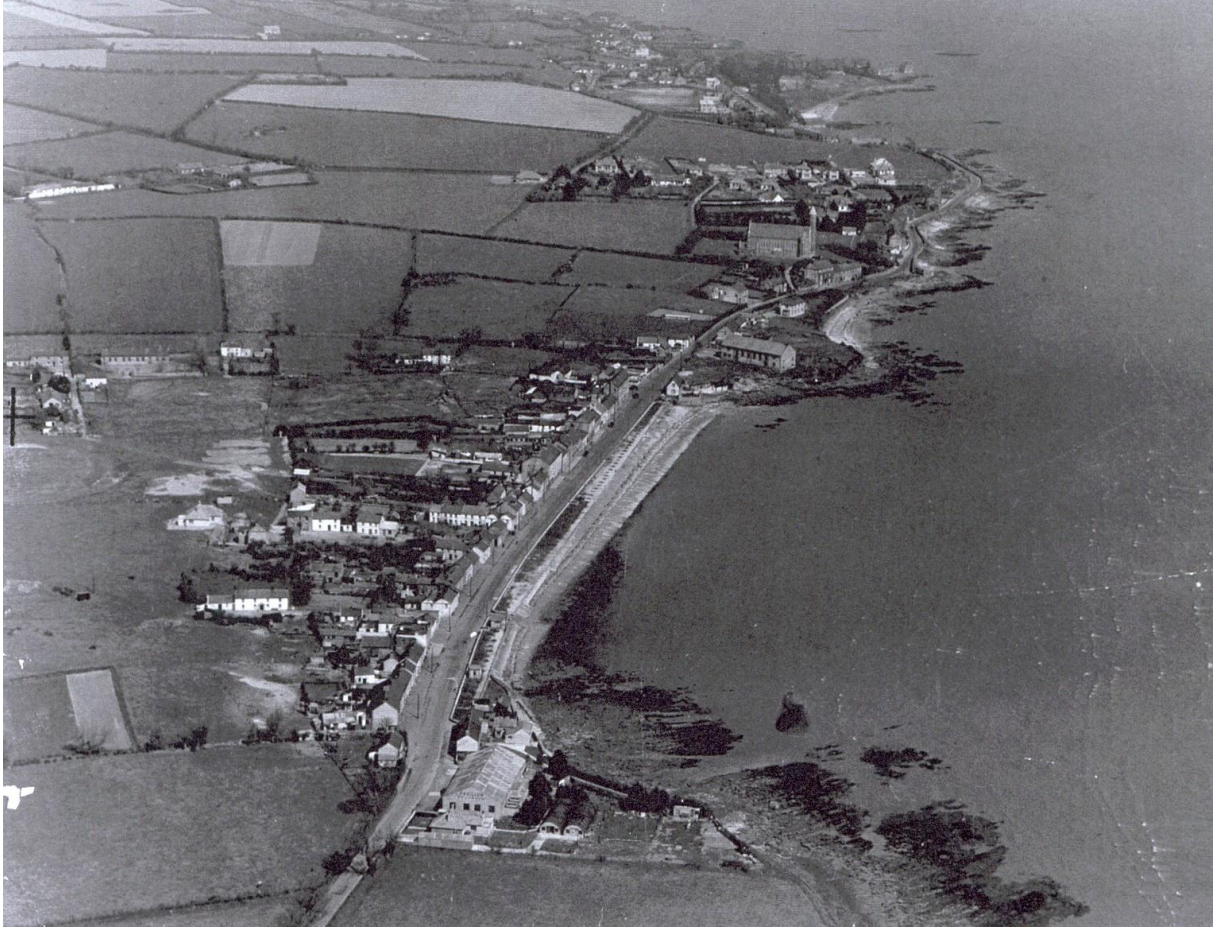
Photo 2: Beach *circa* 1950. Note beach width wider at north than at south indicating possible accretion at this location. Also note High Water mark as indicated by feint black line running along the beach, narrowest at south and getting progressively wider to the north.

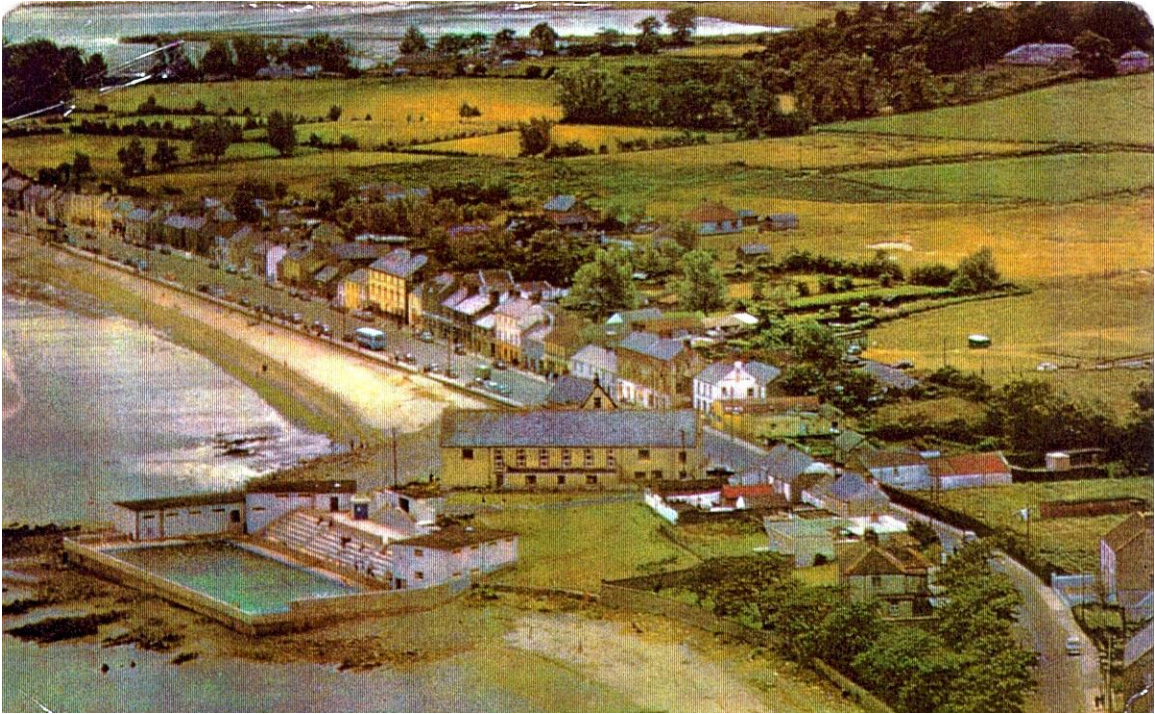
Photo 3: Beach *circa* 1960. Note same variation in beach width at north. Swimming pool now in place but car park not yet built.

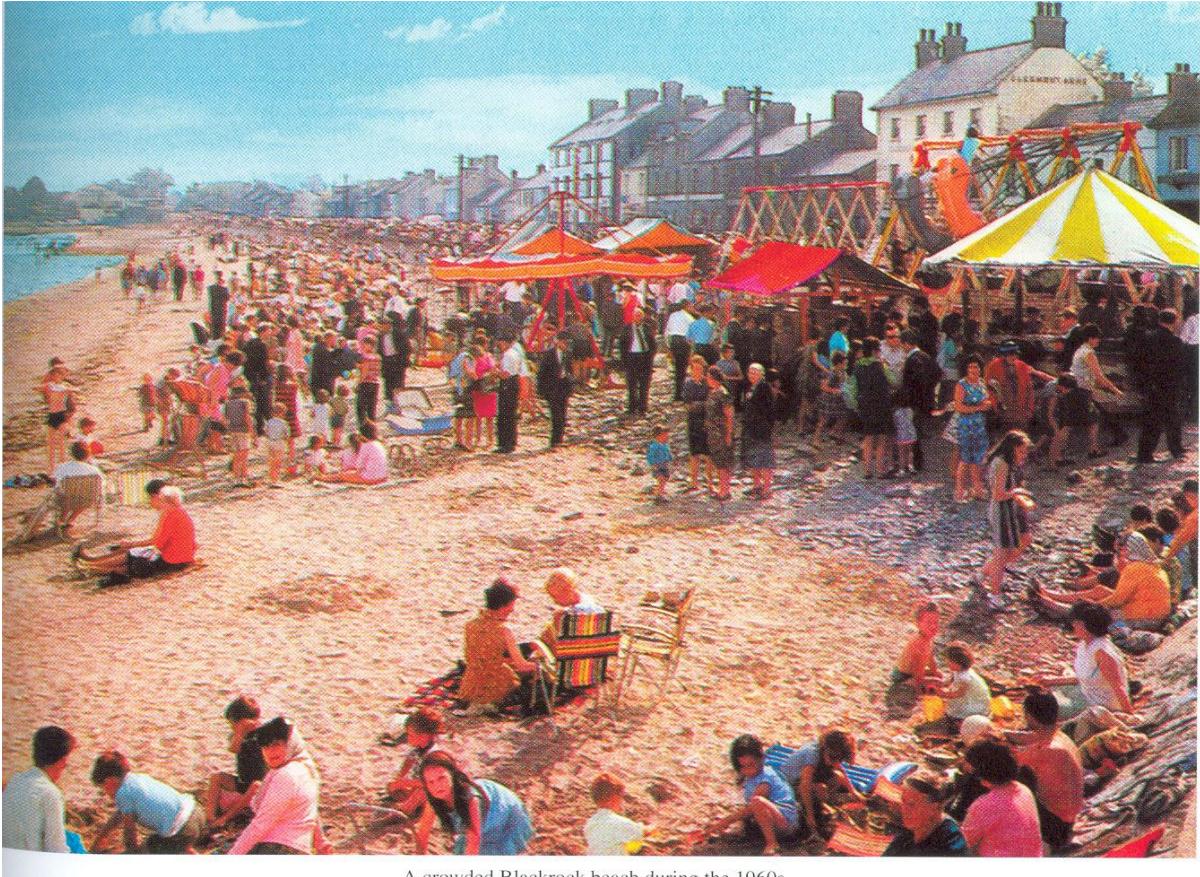
Photo 4: Beach *circa* 1960.

A crowded Blackrock beach during the 1960s

The beach had been an important tourist attraction in previous decades but now sand has moved off the beach and only a small portion remains at the southern end, with the result that there is no dry sand on most of the beach and the northern end has become muddier. Historic photographs of the beach show a clear and consistent band of dry sand along the full length of the promenade and reaching much higher up the promenade sea wall than it currently does (please refer to Appendix 1 for these images).

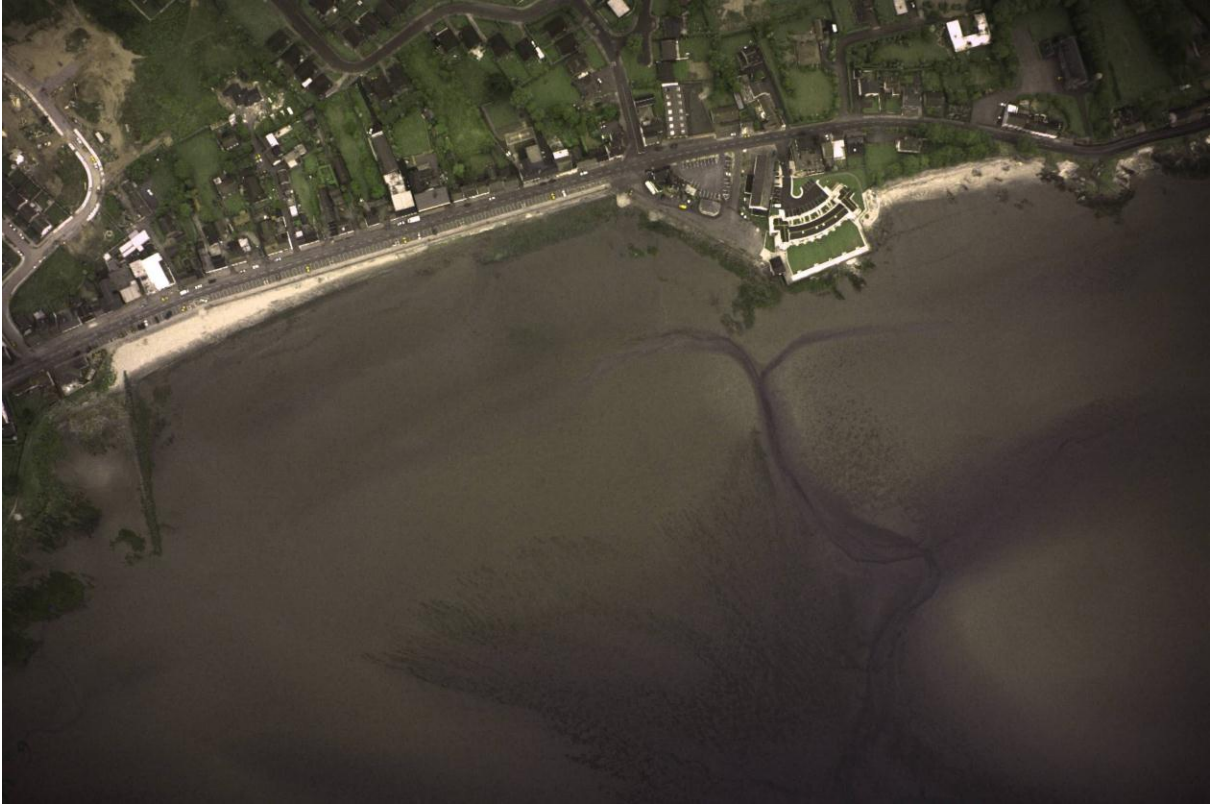
Photo 5: Beach 1998. Note eroded profile of beach at northern end, new car park, build up of material to the south of storm water outfall, and unchanged profile of Priest's beach.

The suite of photographs presented in Appendix 1 shows how the profile of the beach has altered since the earliest image was taken in the late 1890s. In the photos up to the 1960s, there is a clear band of sand *circa* 15 m wide that extends seaward from the promenade wall. In addition, it is clear that the width of the beach at the northern end is *circa* twice as wide as it is at the southern end. This indicates possible accretion at this end of the beach. In the above image (Figure 2-3), taken in 2004, this situation had changed quite obviously with the northern end of the beach now *circa* half as wide as the southern end. This is also clearly evident in Photos 5 and 6 in Appendix 1. One notable alteration in the local shore line morphology is the new car parking area at the northern end of the promenade. This is visible in both Figure 2-3 above and Photos 5 and 6 in Appendix 1. The outfall pipe at the southern end of the beach is also visible in both these images. What is also noticeable is the rate of accretion to the south of this outfall between the 1998 and 2005 images.

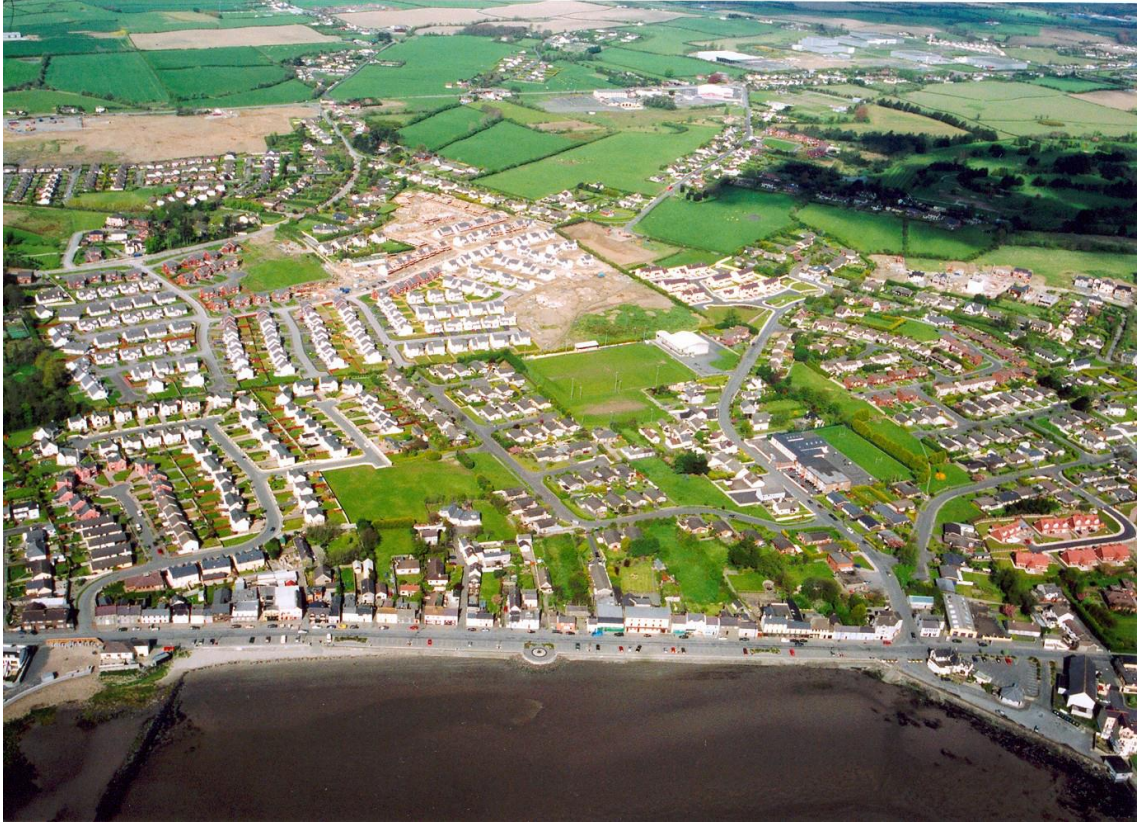
Photo 6: Beach 2005. Note further build up and vegetation to the left of the outfall pipe at southern end of beach.

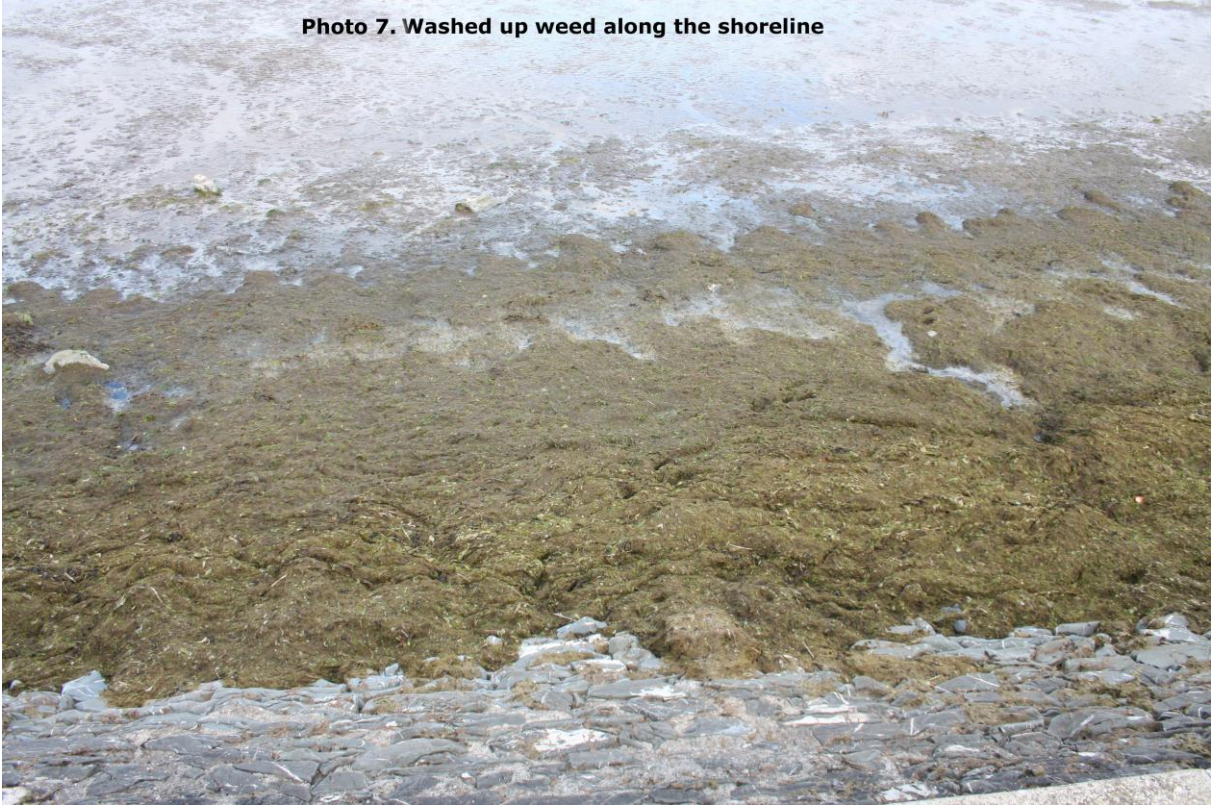
Photo 7. Washed up weed along the shoreline

Prevailing wind direction in the area is from the southeast around to the southwest. This indicates that the net long shore drift is northwards. However, this situation is very much dependant on wind conditions on any one day and this will be an important factor in relation to the build up of weed on the beach (see Photo 7 in Appendix 1).
